RESEARCH REPORT SERIES no. 32-2012

STONEHENGE LASER SCAN: ARCHAEOLOGICAL ANALYSIS REPORT

ENGLISH HERITAGE PROJECT 6457

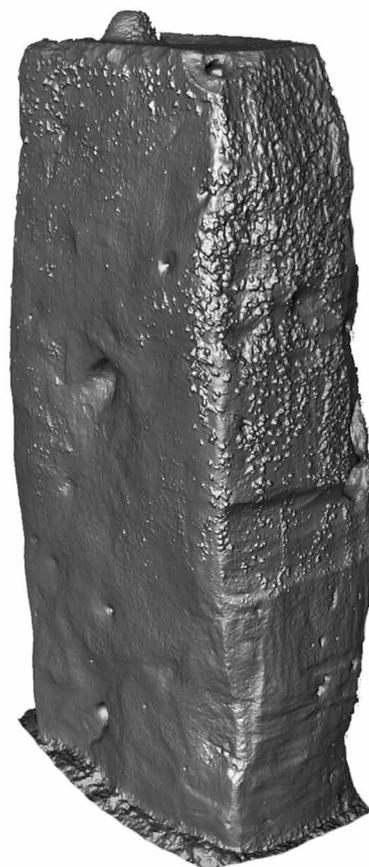
Figure 6. Fine longitudinal and fine transverse tooling on the NE side of Stone 60

Fine tooling, transverse. Small, shallow transverse grooves are visible, measuring 5-10 cm wide by c.20-30 cm long and c.5-20 mm deep (Figure 6). As previously noted, this mode of tooling often extends from, and may be broadly contemporary with, the coarse dressing with longitudinal ridges and transverse tooling. The coarsest forms of this dressing appear to be overlain by longitudinal fine tooling (e.g. NE face of Stone 60), but fine versions of the tooling exist, which are of comparable quality to the longitudinal fine tooling; however, in these cases no stratigraphic relationships can be determined. This style of tooling is found on all of the stones in the Sarsen Horseshoe, but it occurs only on one rebate on Lintel 122 in the Sarsen Circle. In many cases, this tooling is overlain by fine pick dressing and, in the majority of cases, virtually all traces of this mode of tooling have been removed. This tooling may have been created using handheld light to medium-weight hammerstones of c.0.5-2kg. Example: Stone 60 NW exterior face (comparatively coarse); Stone 54 SW side, towards base (fine).

Fine tooling, longitudinal. Small shallow longitudinal grooves are visible, measuring c.5-7.5 cm wide by c.20-30 cm long and c.5-15 mm deep (Figure 6). This tooling is typically slightly finer than the transverse fine tooling. On the Sarsen Horseshoe this style of dressing is found on the sides of Trilithons 1 and 5 (Stones 51, 52, 59 and 60) and one area was observed on Stone 53 (Trilithon 2). In the Sarsen Circle this dressing occurs on the sides of 17 uprights, 1 interior face (Stone 22) and 1 exterior face (Stone 30). This dressing was also recorded on Sarsen Circle Lintel 102 and on one side of the Slaughter Stone (Stone 95). This tooling may be created using a light to medium-weight hammerstone of c.0.5-2kg.

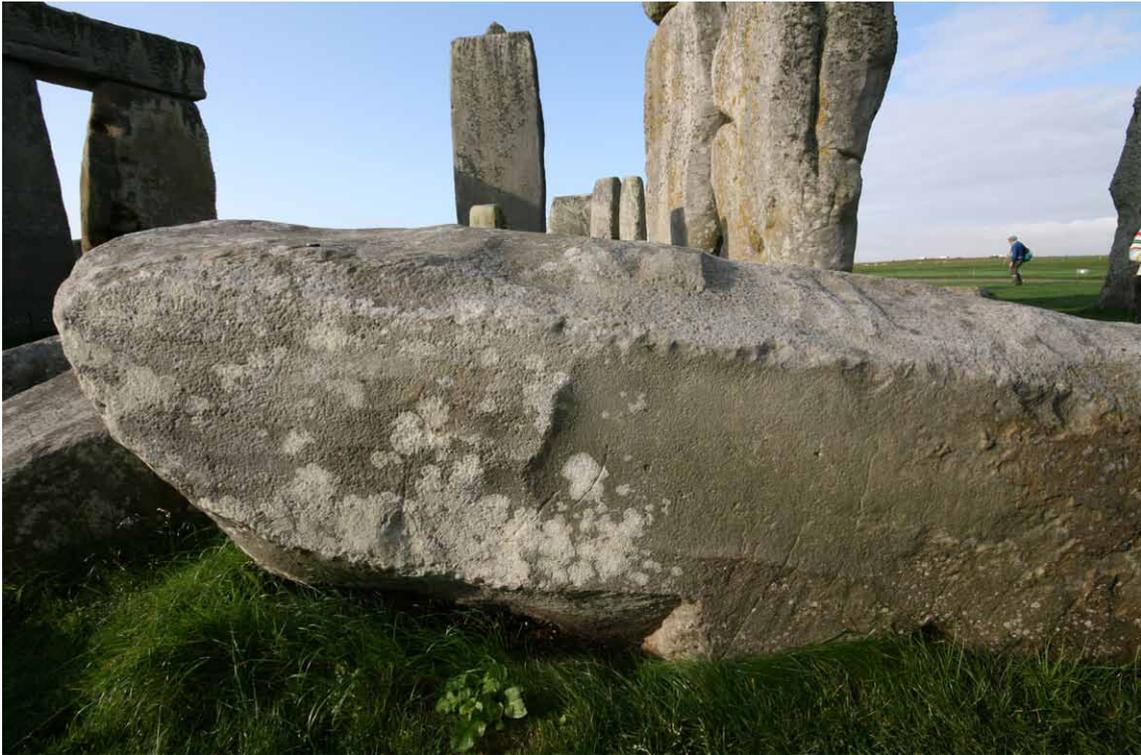
Figure 7. Very coarse pick dressing on a rebate in Lintel 102. The rebate is the rectangular depressed area directly above the upright. (Photograph Hugo Anderson-Whymark)

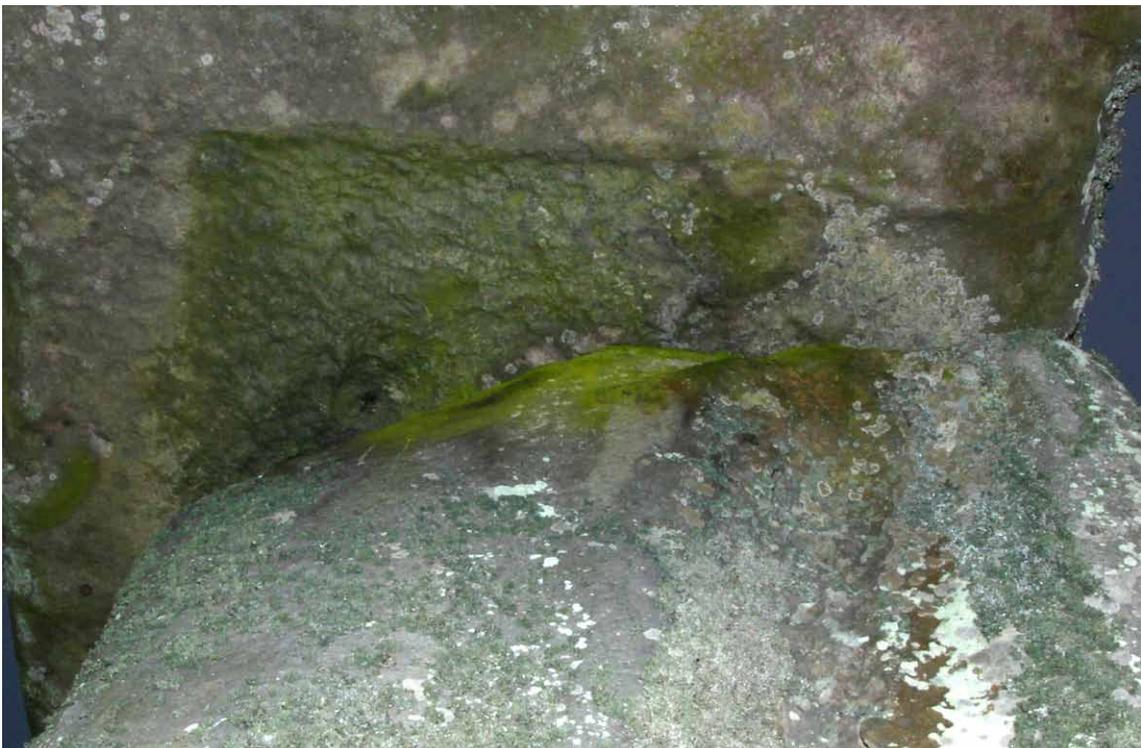
Figure 8. Stone 59a NE side; Fine transverse tooling (bottom) and fine longitudinal tooling overlain by coarse pick dressing (left), which in turn is overlain by fine pick dressed surface (right). A fragment of stone is missing from the bottom left hand edge. (Photograph Hugo Anderson-Whymark)

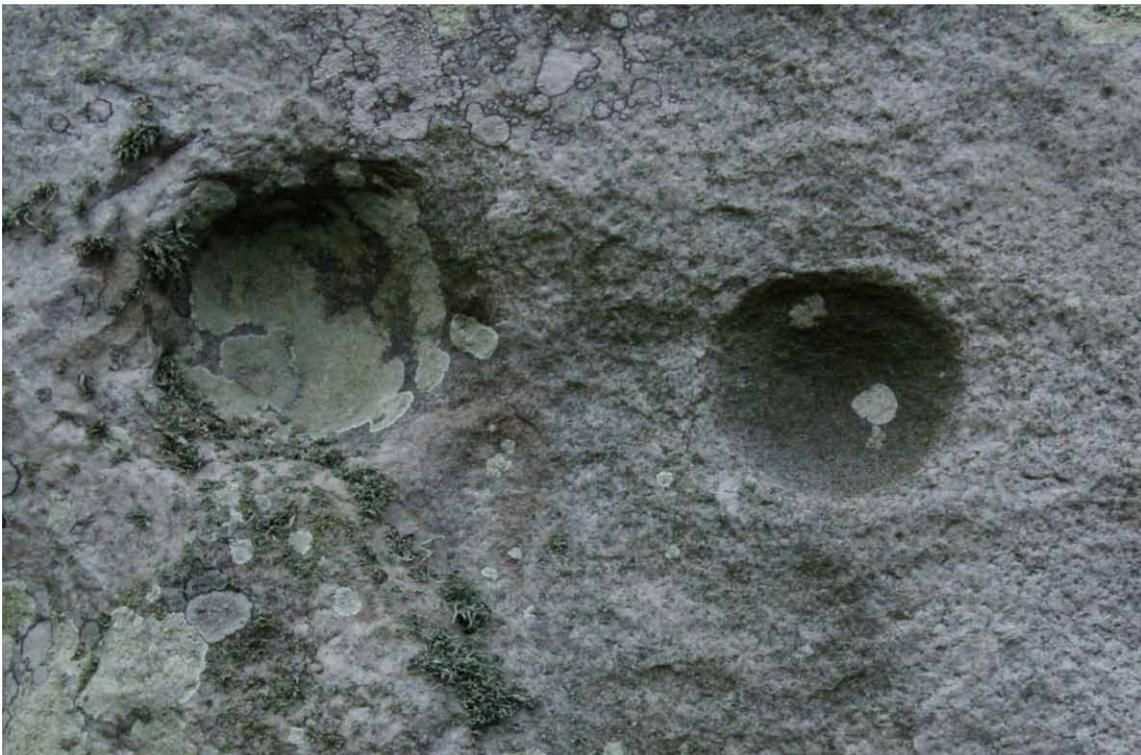
Figure 10. Many natural hollows, such as these on the NW face of Stone 60 resemble cup marks but are natural irregularities in the sarsen surface. (Photograph Hugo Anderson-Whymark)

It is also frequently stated that cup-marks are present on the stones, although past accounts fail to specify locations. Numerous regular hollows (Figure 10) were located on the surfaces of the stones during this analysis, but all appear to represent natural irregularities (e.g. SW face of Stone 57, F.148) or casts of pebbles that have been lost (e.g. W face of Stone 30). Careful examination of all hollows and possible cup-marks, both in the laser-scan data and in the field confirmed that no working is present in the hollows.

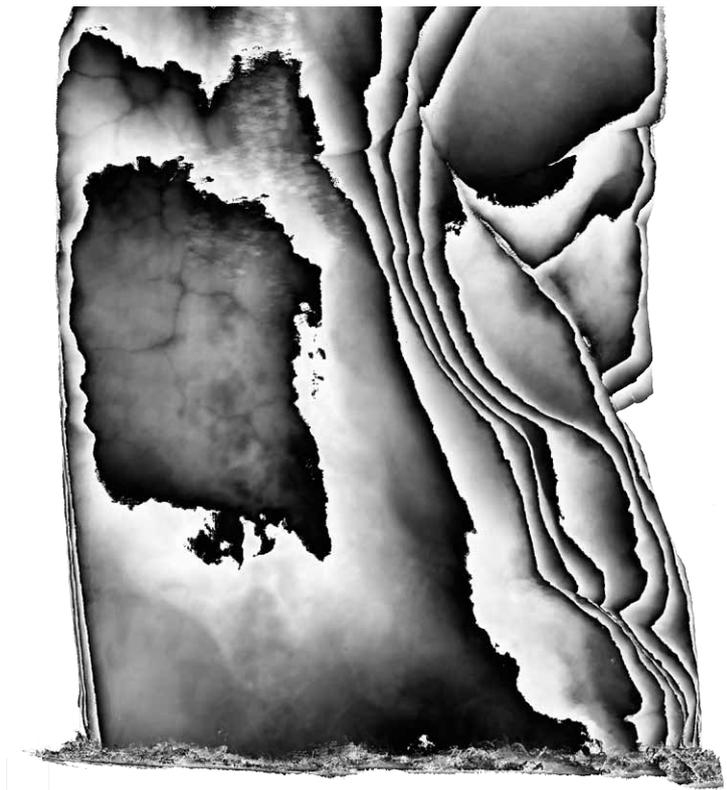
Example greyscale offset image 7.5cm band

Figure 11. Axe-head carvings on the exterior east face of Stone 3

Three clear axe carvings were discovered down the exterior E face of Stone 3 by R.S. Newall in 1953 (Figure 11). Analysis confirmed the presence of these carvings; no new

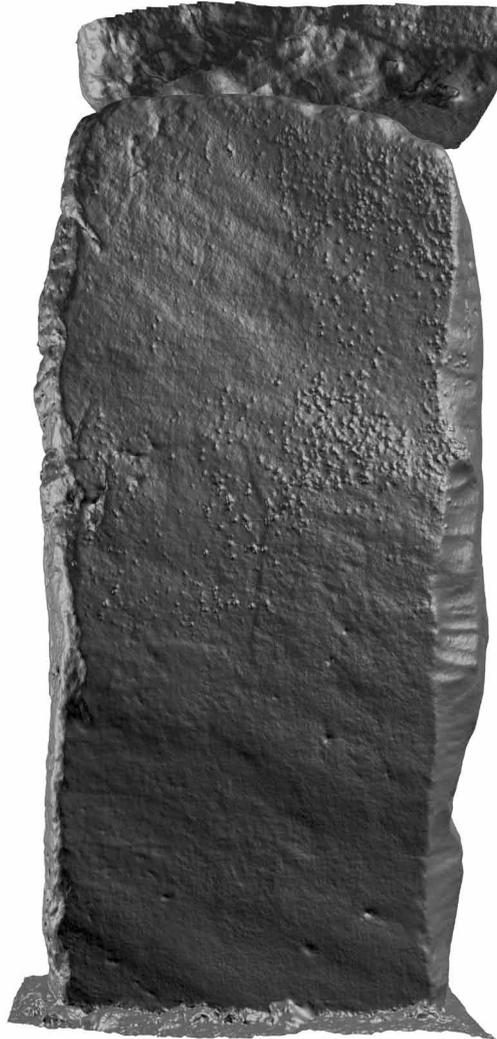
Figure 18. The 'quadrilateral' carving, reinterpreted as an area of stone-dressing, on the SE face of Stone 57

A quadrilateral symbol was recorded on this stone by R.S. Newall in July 1953 (Figure 18). This symbol has been the subject of much debate, as it was initially reported as a Breton-style 'shield-escutcheon' or box-goddess symbol (Atkinson 1956, 32). This interpretation has long been questioned; not only is the carving unclear but radiocarbon dating has placed the Breton carvings millennia earlier than Stonehenge (Lawson and Walker 1995, 30-34; Lawson 2007). The laser-scan model reveals this 'quadrilateral' to be part of a much larger complex of lines that appear to relate to the pick dressing of the surface. Notably, rectangular panels, possibly representing the working area of individual stone masons, are present on a number of stones (e.g. Stones 12, 54 and 60).

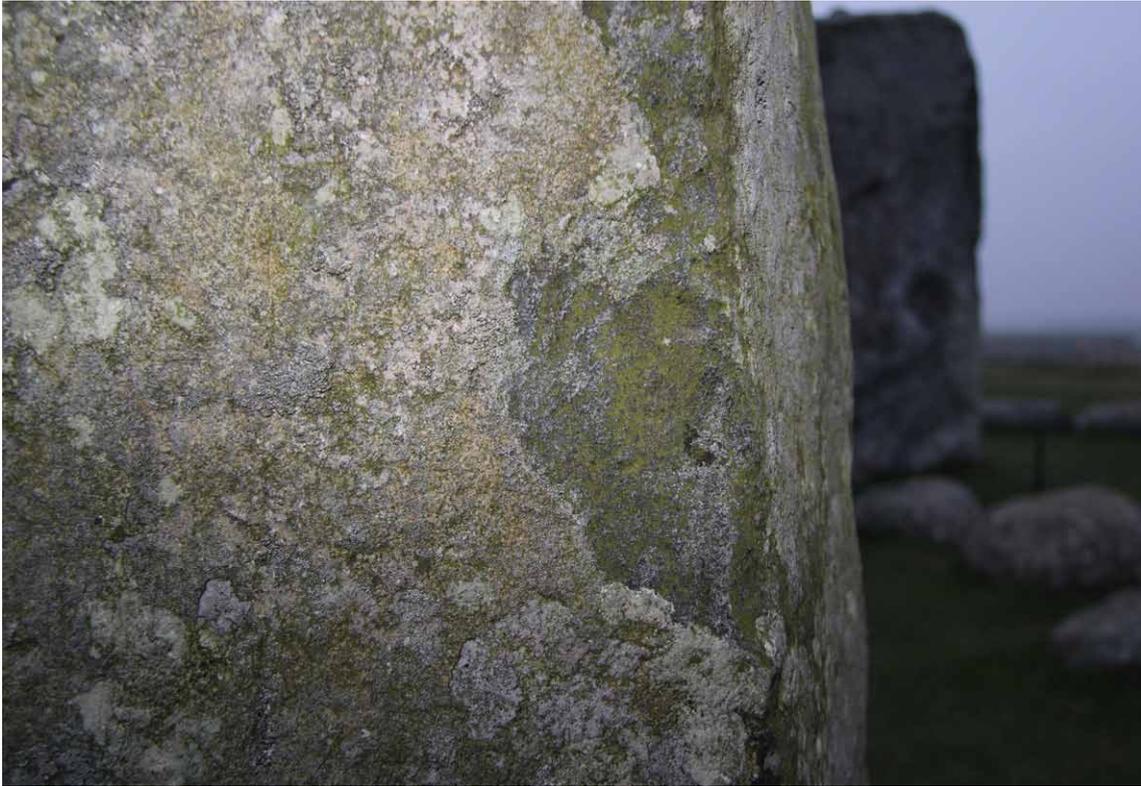
Figure 21. Visitor flaking to the SW edge of Stone 62; Note the weathered stone surface and unweathered flake scar (Photograph Hugo Anderson-Whymark)

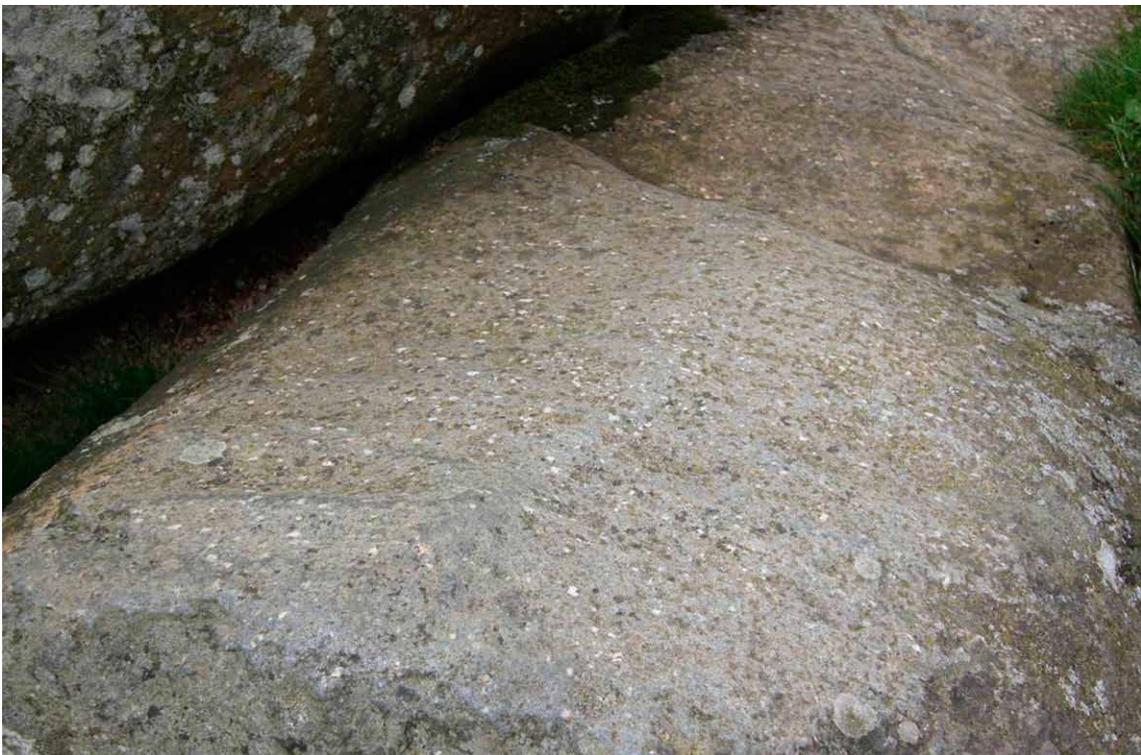
Figure 22. Polish from footfall on the exterior SW (now upper) surface of Stone 67 (Photograph Hugo Anderson-Whymark)

In addition to the intentional damage caused by visitors to Stonehenge, various forms of incidental damage have been caused. Polish and wear from footfall is apparent on many of the fallen stones, but the fallen bluestones have fared worst than the sarsens. Stones 38, 39, 40 of the Bluestone Circle and Stones 67 and 72 of the Bluestone Horseshoe

all exhibit considerable wear to their exposed surfaces and, in most cases, this damage appears fresh; these stones lie in parts of the monument where they are still frequently stepped upon to negotiate other fallen stones (Figure 22).
